LJ20 Distributor - Disassembly Inspection Repair

“Old Codger New To Old Suzuki Jeeps”

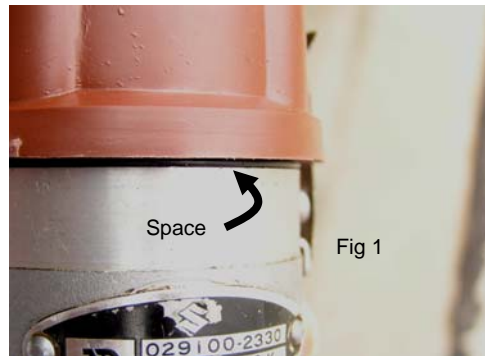
2. Determined the thickness of the “O” ring under the cap. (Fig 1)

A. The cap sets on top of the “O” ring instead of fitting over it. Replacing the “O” ring with one that was thicker could affect the distance between the rotor and terminals inside cap.

- i. For the new ring under the cap, had to use one with a smaller outside diameter ring. The resulting stretch reduced the diameter of the rubber to where the space under the cap was acceptable. (See step 1.0 Fig. 1)

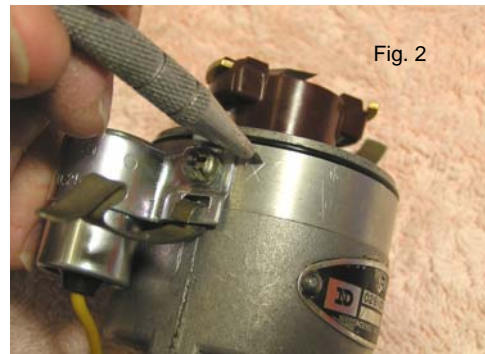
4. Scribed a mark on the outer housing where the condenser is attached. (Fig. 2)

A. All scribe marks were made to help with re-assembly.

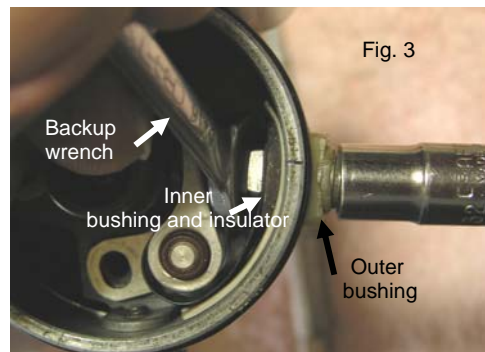
6. Removed the nuts (2) and all washers from the terminal bolt going through the distributor housing. (Fig. 3)

Caution: Used a backup wrench on the bolt head to prevent turning and damage to the inner or outer plastic bushings and insulator.

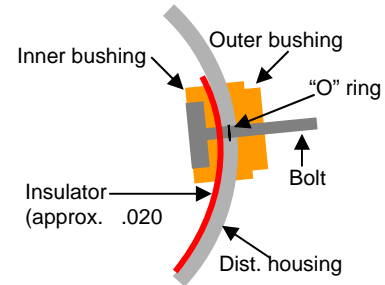
Fig. 4

7. **Removed points carefully to protect insulating material and inner bushing.** (the insulator was old and brittle and broke into two pieces anyway)
8. **Removed terminal bolt with inner bushing attached.**
Did this carefully and by working bolt to one side.
(Fig. 4)

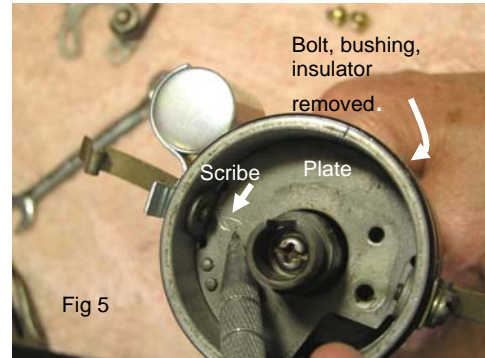
9. **Removed distributor plate. (Fig. 5)**
 - A. Scribed a mark on the plate where the bolt holding the condenser and distributor cap clip comes through the case.
 - B. Removed screws from both of the clips that hold the cap on then removed the clips.
 - Caution: There is an "O" ring for each of the bolts.**
 - C. Removed plate from housing.

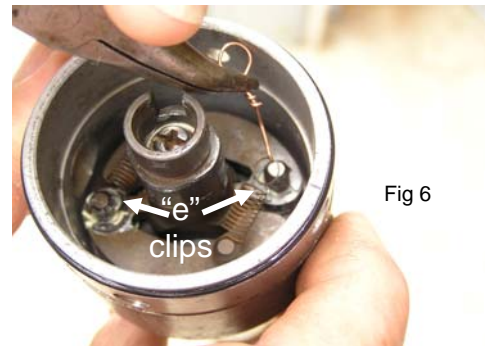
10. **Removed centrifugal advance weights. (Fig.6)**
 - A. Removed one end of springs from each of the weights. Removed at the end with the "e" clips leaving spring attached at other end. (Hook for removing springs was made from MIG welding wire) **Caution: Was careful not to overstretch or damage springs.**
 - B. Removed both "e" clips. (Fig 6)
 - C. Lifted weights with springs attached from their shafts.

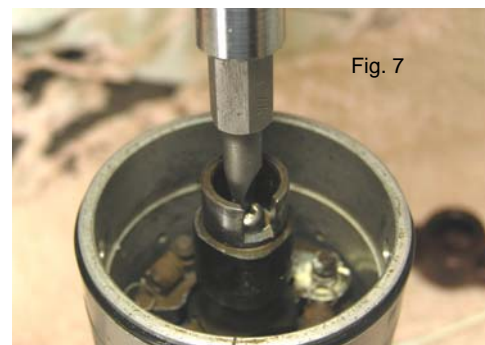
11. **Removed distributor cam. (Fig. 7)**
 - A. Removed center screw from cam. Had to hold gear to do this.
Caution: Screw was rusted in place. It would be very hard to drill out if damaged. Applied penetrating oil (PB Blasters) followed by holding Phillips screwdriver (with good tip) in place while gently tapping down on handle with a light hammer. Did this intermittently over a period of several hours before screw could be removed.
 - B. Lifted cam from shaft.

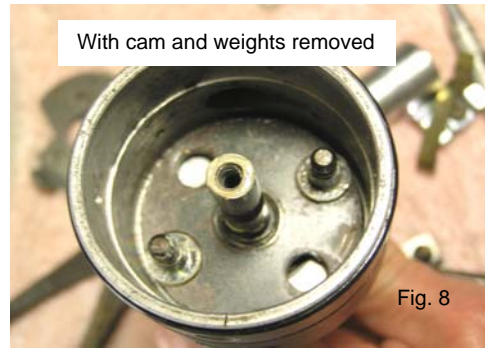
C. Picture with plate, cam and weights removed. (Fig 8)

Note: If the upper shaft bearing was not going to be replaced, this would have been the extent of the disassembly.

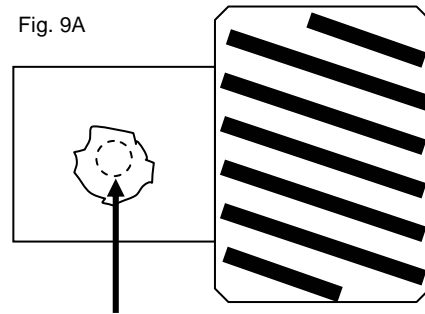
Fig. 9A

- A. Used small grinder and file to cut each end of the pin to where it was very slightly below the surface of the gear. This allowed a faint outline of the pin to be seen. **(Fig. 9A)**
- B. Determined what end of the pin was the smallest diameter.
- C. Used a pin punch smaller than the pin and hammer to try to back the pin out. *Was not successful*

Faint outline of pin in ground off area

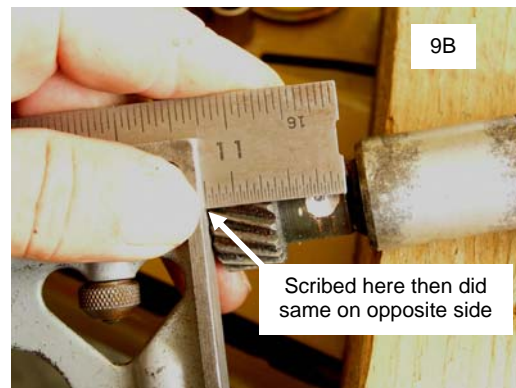
- D. Used a small square and scribe to mark alignment of center of pin with bottom of gear. Did this for both ends of pin. **(Fig. 9B)**

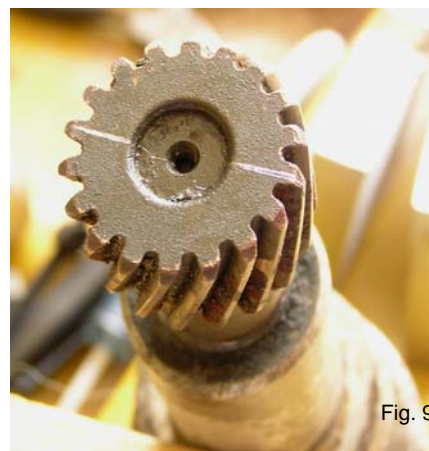
- E. Used scribe and straight edge to mark bottom of gear connecting the two marks made in the previous step. **(Fig. 9C)**

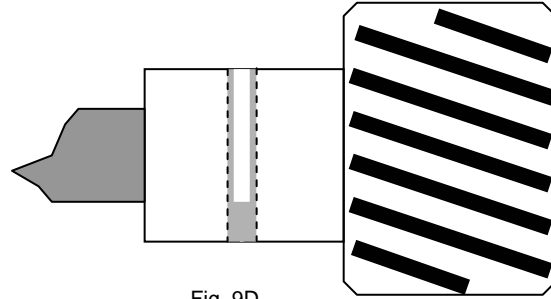
Fig. 9D

- F. Visually aligned mark on bottom of gear with drill bit and then drilled part way through the length of the pin. (Fig. 9D)

Caution: Used bit smaller than pin
Caution: The drilling was done very carefully as the bit needs to stay inside the pin to prevent damage to the gear and shaft.

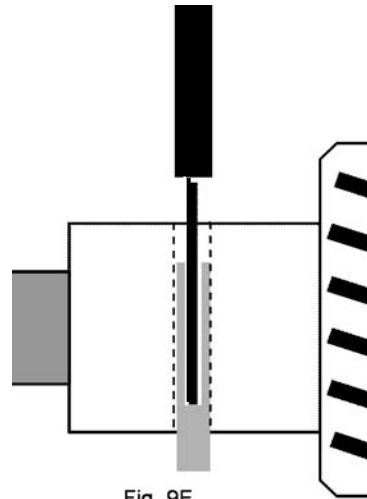
Fig. 9E

- G. Using a pin punch smaller than the drill bit, the remaining portion of the pin was driven out with a hammer. (Fig. 9E)

Note: Placing the punch in the bottom of the hole caused the force of the hammer to actually pull the pin out of the shaft.

Caution: Both gear and housing must be properly supported to prevent bending the shaft due to hammering.

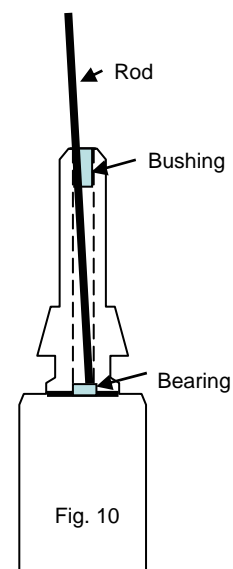
Fig. 10

15. **Removed ball bearing from housing.** (There has to be a puller somewhere for this purpose but this is how this "Okie" did it)
- A. Working from the top of housing, removed "C" clip from top of bearing.
- B. Working through the bottom bushing, a small rod and light hammer was used to drive the bearing out of the housing.
- i. Did this by moving the rod back to forth and right to left, to tap lightly on alternating sides of the bearing race. The intent was to cause the bearing to move a small amount with each tap.

Caution: As the steel rod was harder than the aluminum housing, this had to be done very carefully to prevent damage to housing.

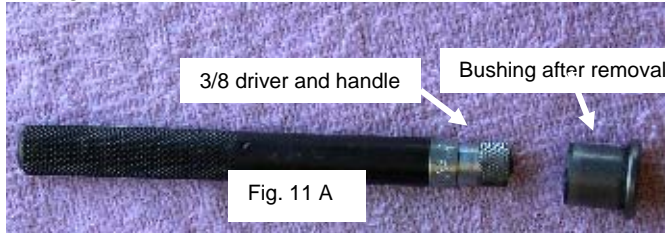
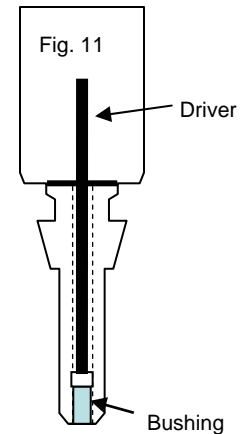
16. Removed bushing from bottom of housing. Note: Although the bushing was reused, it had to be removed to allow the new upper bearing to be properly pressed back into the housing and the shaft back into the bearing.

A. Working from top of housing, a driver with a 3/8 in. end was used to drive the bushing out the bottom of the housing. (Fig. 11 and Fig 11A)

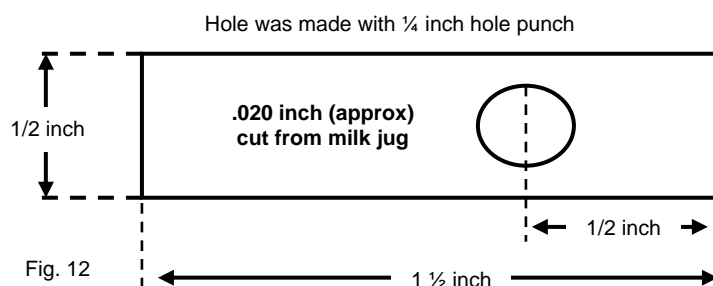
- G. Points, condenser, rotor and cap were purchased new from Steve @ Brute 4 Parts.
- H. Inner and outer plastic bushings on bolt were reused.
- I. Due to the broken insulator, a new one was made using plastic cut from side of one gallon

plastic milk jug. (Fig 12)

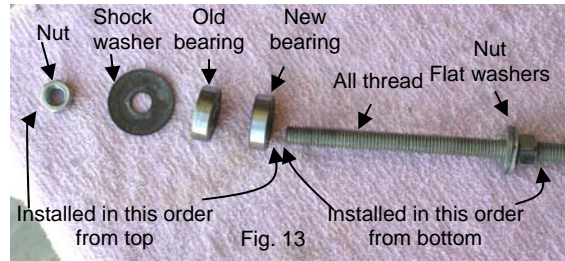
- B. A puller was made using 3/8 in. "all thread" with nuts, flat washers, and one "cupped" 3/8 in. washer from a shock absorber, plus the old bearing. (Fig. 13)

- Positioned new bearing in case.
 - Installed other parts as shown. (Old bearing was used to prevent damage to new one – The shock washer was installed cup side down so it would press on old bearing's outer race only)

- Used socket and wrench to pull new bearing part way into cavity in housing, stopping just before old bearing was about to enter cavity.
 - Removed old bearing from puller and in its place added the bushing driver selected in step "A" above.

- Reassembled puller and completed pulling new bearing down into cavity being careful that the bushing driver did not contact/damage the distributor housing. .

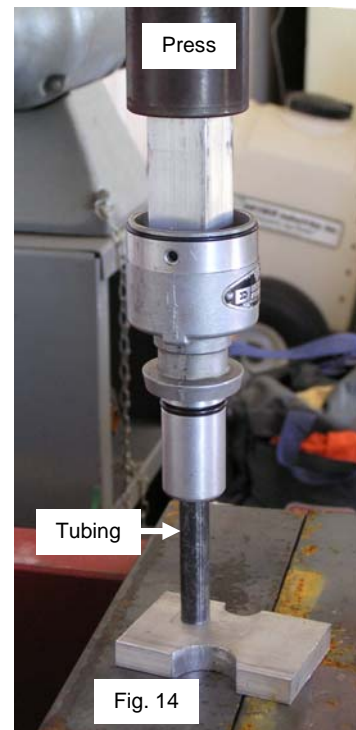
21. Pressed shaft into bearing. (Fig 14)

- Cut piece of 1/2 inch thin wall steel tubing (Lowe's Home Improvement) slightly longer than bottom part of shaft.
- Placed shaft into new bearing from the top and slid shaft into the bearing as far as it would go with hand pressure.
- Placed tubing over bottom of shaft in housing to the point that the tubing was against the bottom of the inner race of the new bearing.
- With a small block of aluminum protecting the upper end of shaft, a press was used to press the shaft down into the bearing.

Caution: Not wanting to remove/replace the bottom bushing, I first tried driving the shaft into the bearing with a small hammer and without having the tubing to back-up the inner race of the bearing. This resulted in a damaged bearing which cost \$17 plus another trip to the parts store.

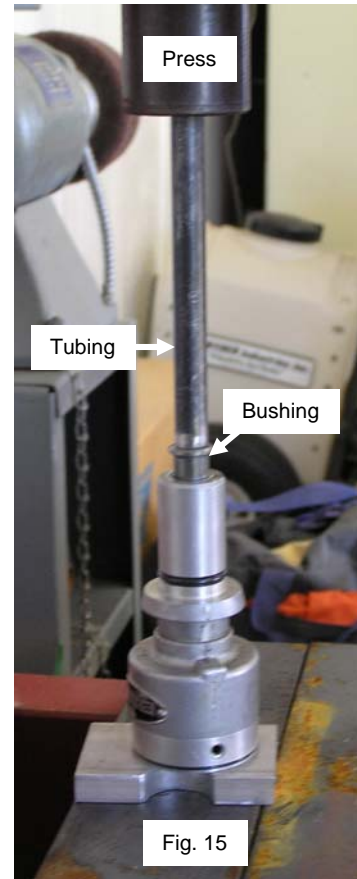
22. Pressed bushing into bottom of case. (Fig. 15)

- A. Placed distributor upside down in the press protecting the open end of the housing with a small block of aluminum.
- B. Pre lubricated shaft with outboard motor oil.
- C. Placed bushing and steel tubing over shaft in that order.
- D. Pressed bushing into case and over shaft.

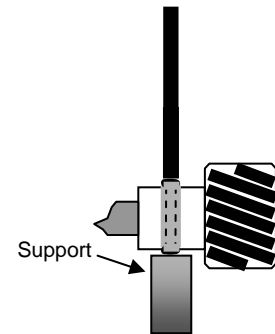
Fig. 16D

F. Using a solid surface as a support, (**Fig. 16D**) the gear was turned one-half turn and the hammer and pin punch were used to peen the opposite end of the pin, making it larger in diameter and tight in the hole.

Caution: Step “F: above was repeated on each end of the pin until satisfied that the gear was solidly connected to the shaft.

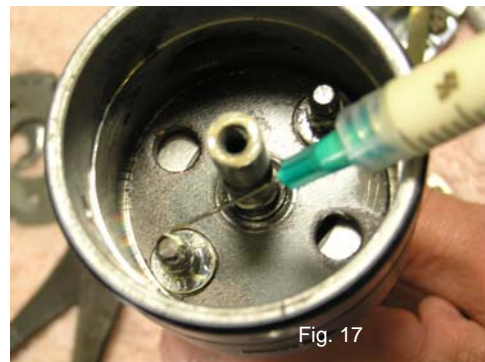
Fig. 17

A. Lubricated the posts that the weights mount to. (CRC White Lithium Grease from local parts store – I put it in syringe) (**Fig 17**)

Caution: All grease inside distributor was applied sparingly.

B. Installed weights to post, installed “e” clips.

C. Attached springs still attached to weights to post.

D. Installed screw.

Caution: The screw should be bottomed out when tight leaving the cam free to rotate slightly on shaft. If it can't be easily rotated slightly by hand, something is wrong.

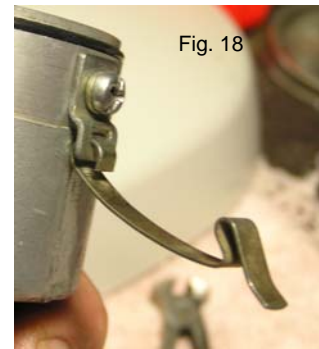
Fig. 18

- B. Assembled clips as shown. **(Figure 18)** Note that part of one of the clips is made on the new condenser.
- C. Installed new “O” rings on bolts after the clips. (!/16 X 1/8 X 1/4 inch “O” rings seemed to fit ok)
- D. Installed clips on outside of housing by screwing screws into plate. **Important: The clip attached to the condenser attaches at the scribe mark on the outside of the housing.**

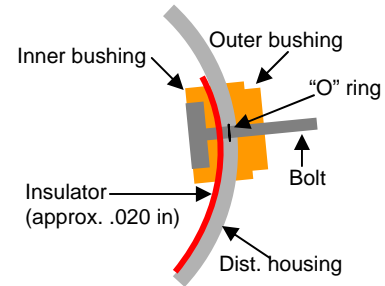
Fig. 4

27. Installed terminal bolt, inner bushings, insulator, “O” ring, and outer bushing. (Fig 4)

- A. Assembled terminal bolt, inner bushing, and insulator in that order and installed from inside of case.
- B. Placed new “O” ring (1/16 X 5/32 X 9/32) on bolt and pushed it into hole in housing.
- C. Installed outer bushing and lock washer and one nut on bolt.
- D. Left nut loose.

Caution: Insulator needs to fit over shoulder on inner bushing. Also, outer bushing has two shoulders requiring that the proper shoulder was installed toward housing.

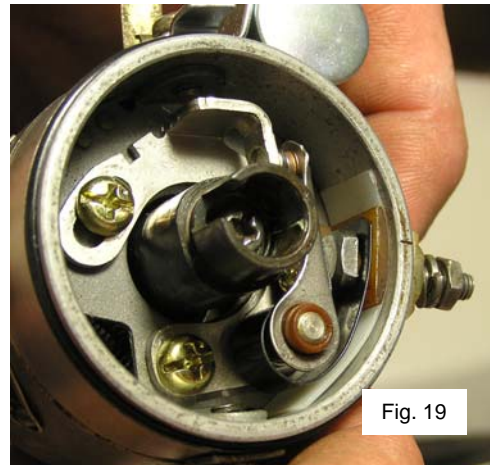
Fig. 19

28. Installed points assembly (Fig. 19).

Insulator must insulate spring on points from housing (see location of white insulator made from milk jug in Fig 19).

The notch on the end of the spring fits over the bolt between bolt head and inner bushing.

The protrusion on bottom of points must be inserted in the proper hole in the plate.

Points must set flat on plate before screws are tightened.
